## SERVICE BULLETIN

REVISION AND MODIFICATION OF THE AUTO SHOCK NOSE TYPE GEAR, CORRESPONDING TO THE DRAG DISTANCE (Trail "T<sub>M</sub>")

*April 30<sup>th</sup>, 2009.*

**SB-Ibis-007**

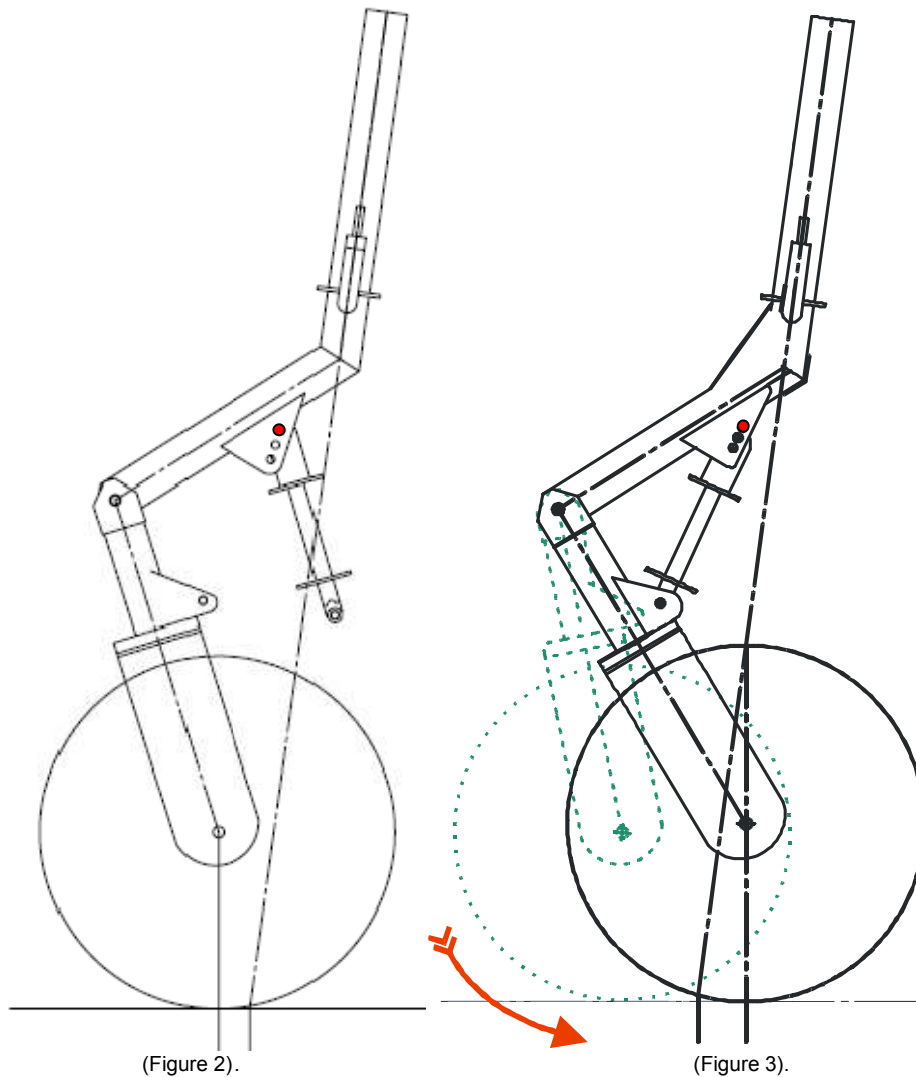
Now remove the fixation at the bottom of the shock absorber in order to locate the wheel within the established range of the gear's design. This is done by moving the whole wheel setting toward the inside of the aircraft (Figure 3).

- ✓ Initially, secure the top base of the shock absorber at the highest point of the gear's plate, and then set it (Figure 2).

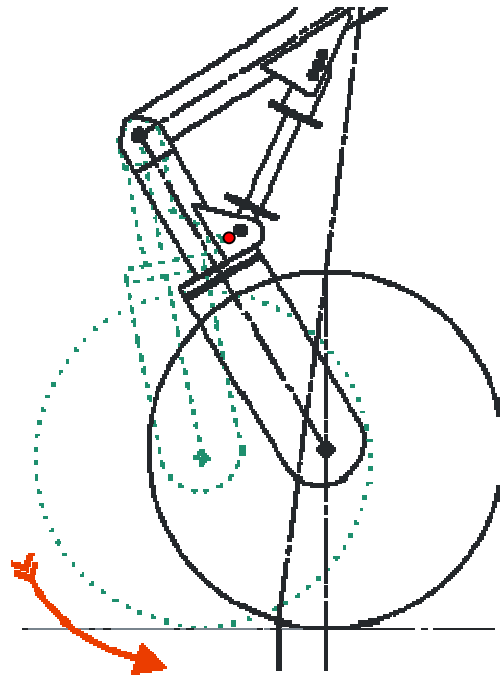
Once the position of the train is within the range is going to mark a new starting point to drill the new position of the base of the shock absorber to the nose gear (Figure 4).

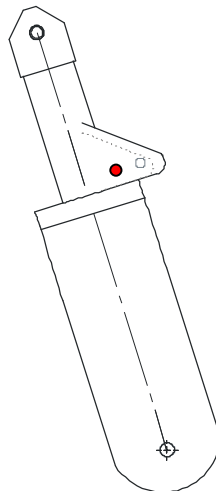
1. The lower part of the gear is removed, what corresponds to the joint and for a better handling the Wheel is also removed (remember that this piece should have the new point marked) because the lower base does not enter the plate due to the gear's plate, the outline should be marked in order to make a new cut on the plate (Figure 5).

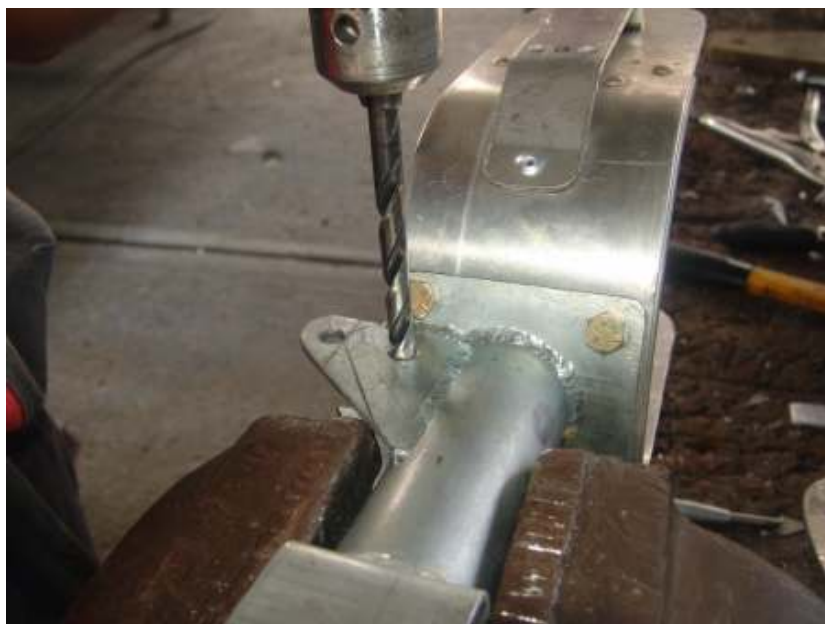
2. At this point make the drilling for the new fixation point of the nose gear's lower base. (Figure 6).

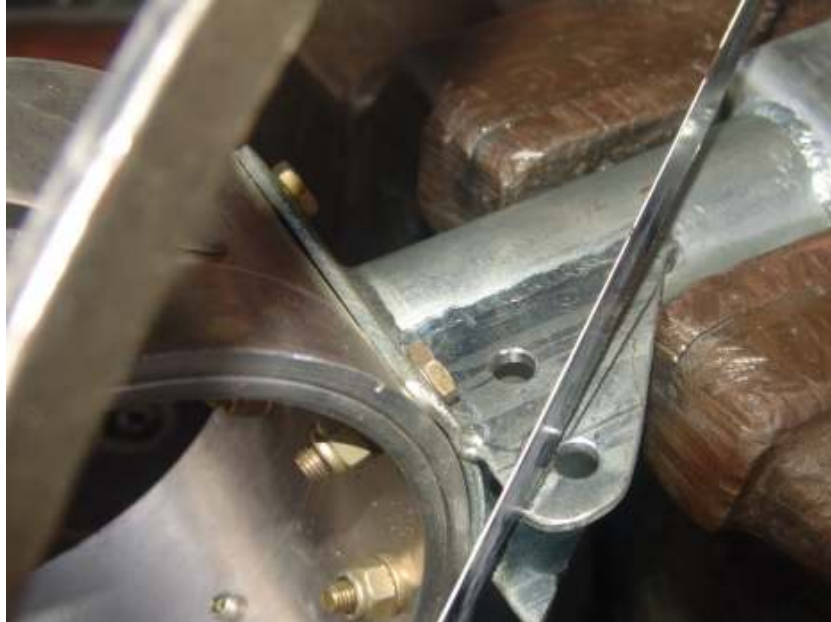
3. After cut the silhouette of the lower gear base, where the lower base of the shock absorber system is fixed. (Figure 7).

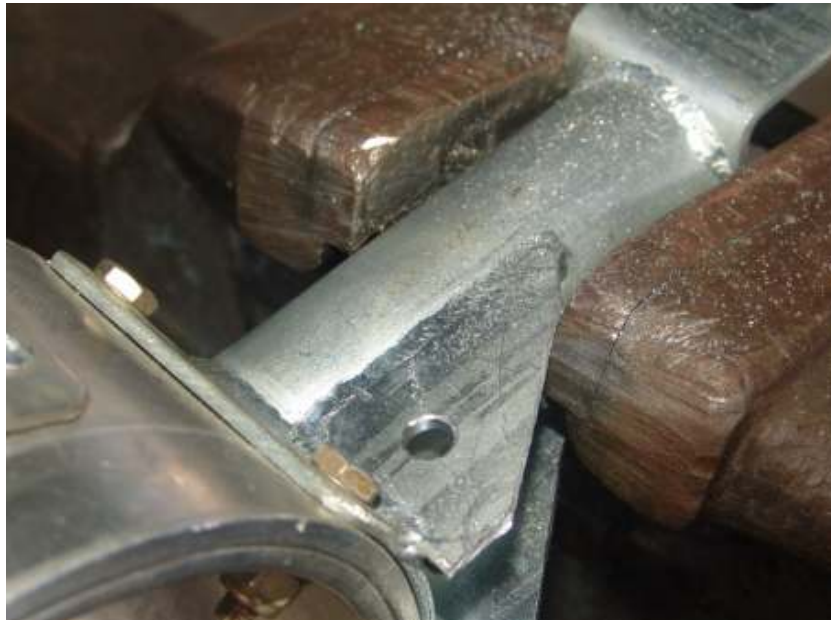
4. This cut should guarantee that the lower base of the shock absorber can be fixed to the new drilling, after the cut should be finished. (Figure 8).

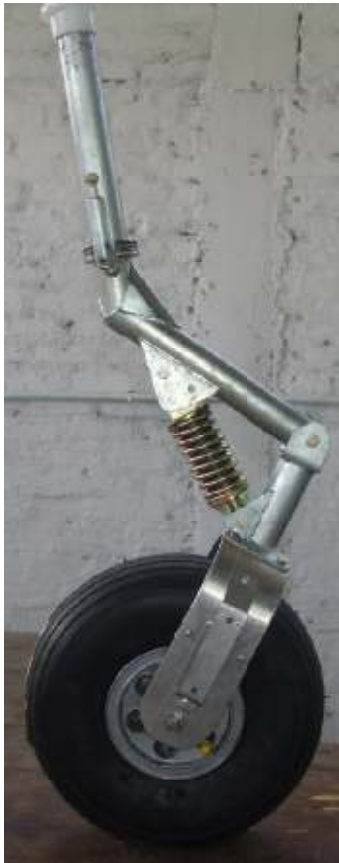
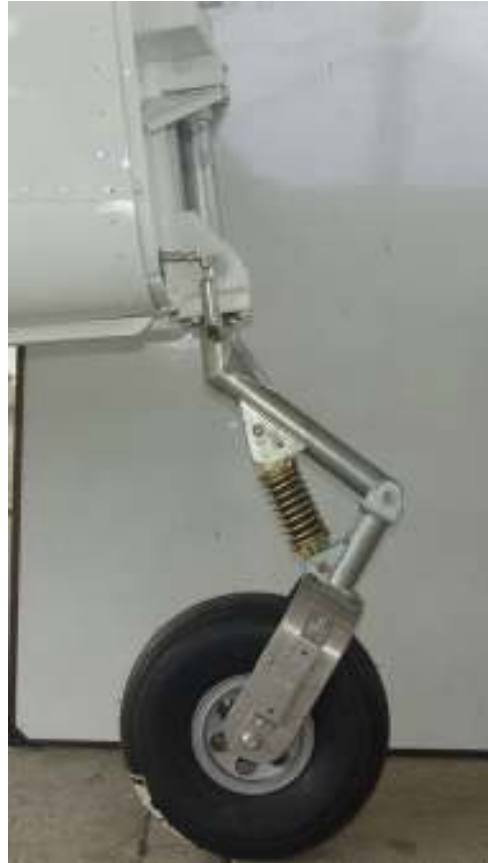
(Figure 9).

5. Finally the gear is mounted in the system and it should be within the parameters established in the design of the nose gear (Figure 9 and 10).
